Bulkhead MASTERCLASS

They are one of the most rot-prone areas on a Land Rover and equally tricky to repair. Kev Mills visits Ashtree Land Rover International to see how a professional does it

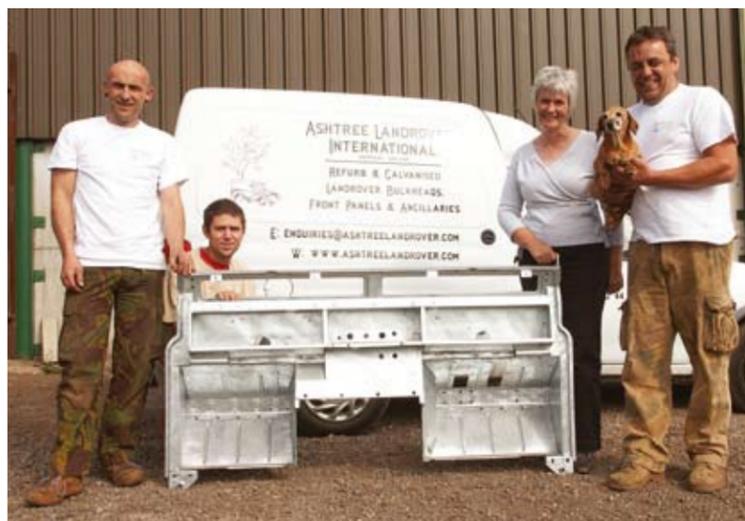
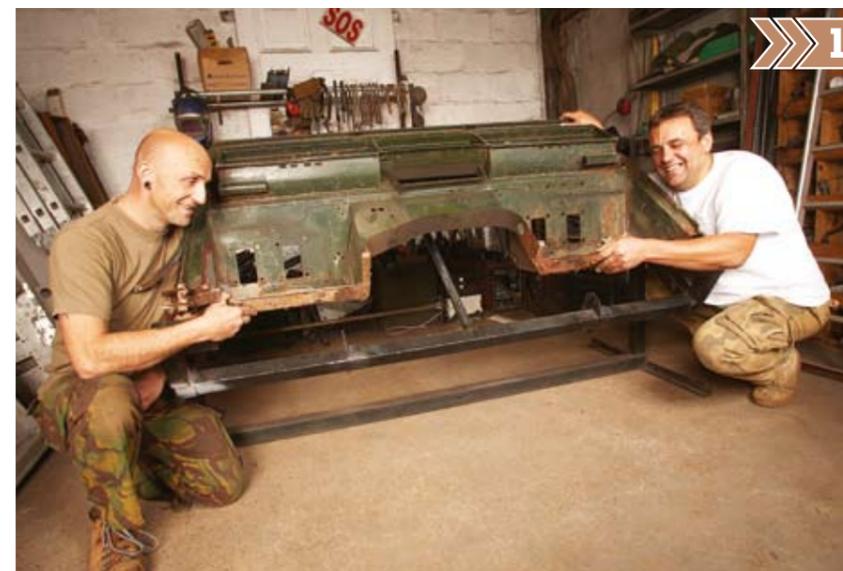
1 Kev and Lyn start by placing the bulkhead in their special jig and thoroughly inspecting it. 'As long as you have the dash and the centre section', says Lyn, 'there's enough to work with. Some need more work than others, but there aren't many we have to write off completely.'

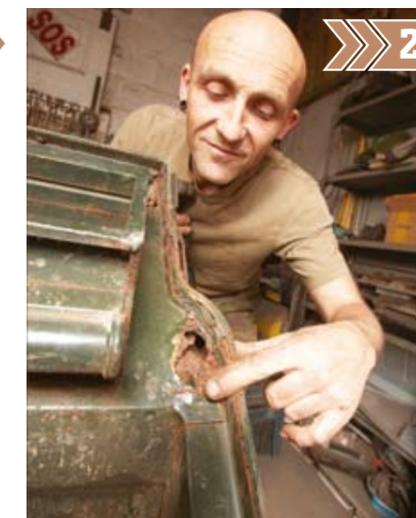
2 Door pillar/shut: this area isn't available as a repair section, so will have to be fabricated. This area is triple-layered for strength, so unless the rot is fully cut out and the metal replaced, any rust will be trapped.

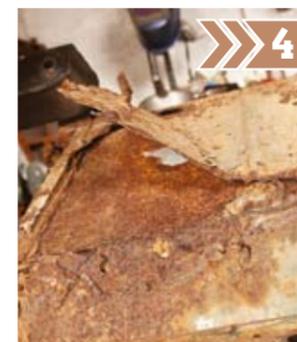
3 Rotten footwells – typical of many older Land Rovers. If the top half is still solid, these can be repaired, otherwise a complete new footwell is required. This one has already been patched at one stage...

4 ...but the original rotten metal was left underneath the patch and has now 'blown' away from the repair.

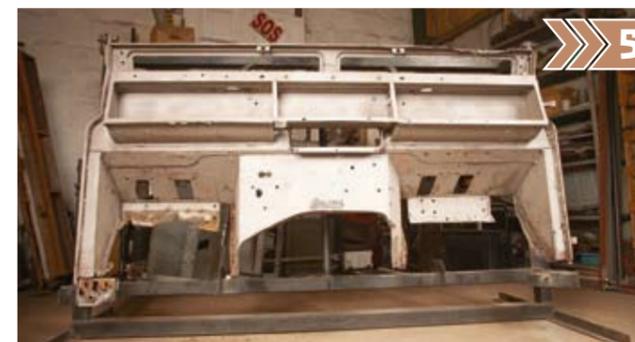
5 Many bulkheads will have years of layers of paint, possibly filler and all sorts of other nasties underneath the surface. The best approach is to get the bulkhead shotblasted, removing any loose rust and leaving clean metal to work with.

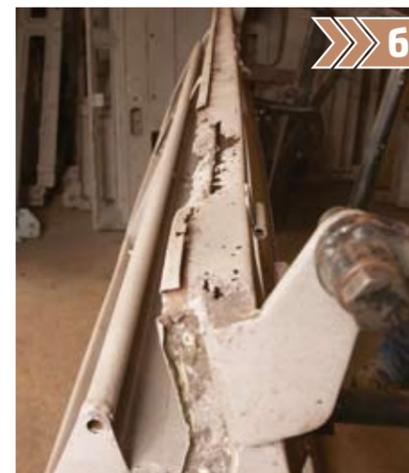
6 The top rail is often badly rotted. Water collects under the windscreen and is trapped by the sealing rubber. This one's been hidden by paint, but is a relatively easy repair...

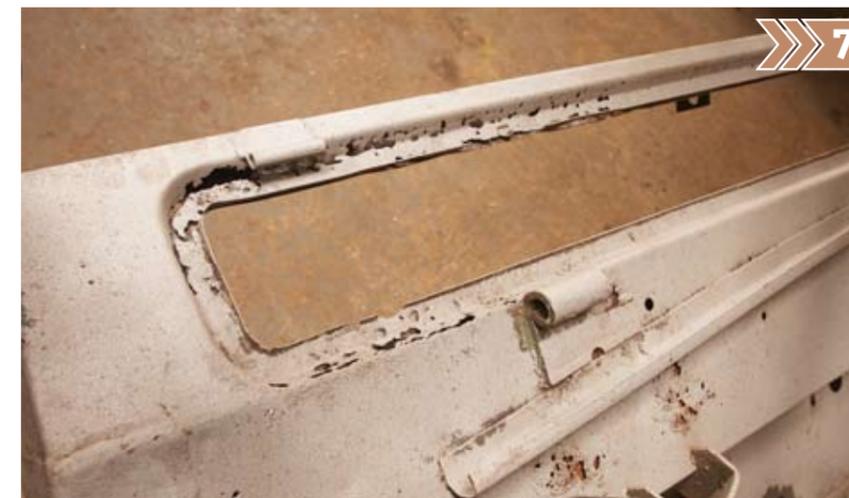
7 ...Unlike the area around the vent flaps. 'This really isn't a job for the faint-hearted', says Kev. 'It will take as long to repair this section as it will to replace a footwell and door pillar. The really bad ones are put to one side and done on a 'as and when' basis.'

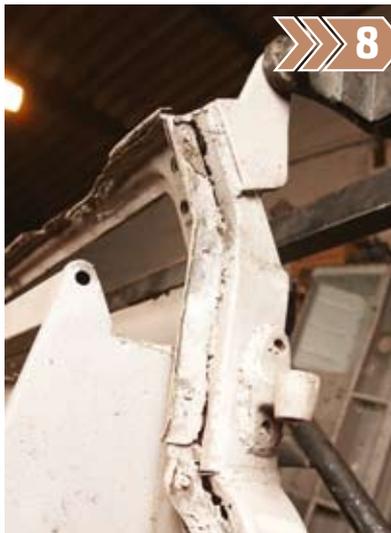
8

Typical of previous owner bodes is this welded-on top door hinge. 'This means a otherwise solid top corner will need rebuilding to get back to standard', Kev explains. 'We see some right lash-ups. As well as filler, we've found complete pages of a 1970s-era Cornish newspaper and even repairs using concrete!'

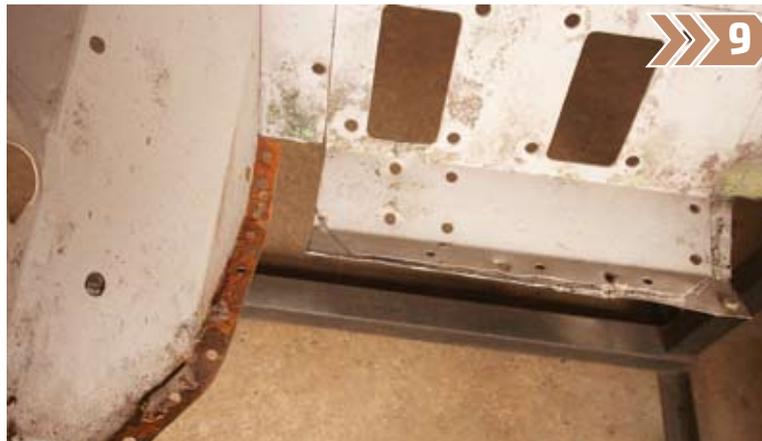
9

Footwells and stiffeners are held in by spot welds. 'We drill these out and remove the complete sections, enabling us to keep the construction similar to original and also remove trapped rust.'

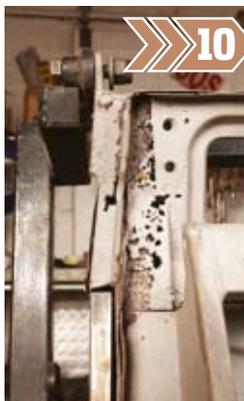
10

Ideally, the top of the bulkhead and windscreen hinge and are held tight in a jig while the door pillar is cut out and replaced. 'Series I, II and IIA bulkheads are the easiest to repair in this way as the dash tray keeps everything stiff - important for the galvanizing later.'

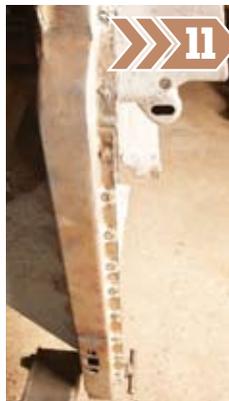
11

Here we see where the door pillar joins the footwell. 'We puddle-weld in the same place they were originally spot welded, for strength and appearance. The lip for the door seal can be added if needed, but more people are using the one-piece Defender-type seals which don't need the lip.'

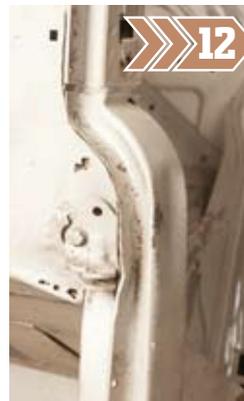
12

A typical fault with Series and Defender bulkheads: the door has swung open too far, tearing the stay bracket away and denting the pillar itself. Despite having no rot, this will all have to be cut out and replaced to get a decent job.

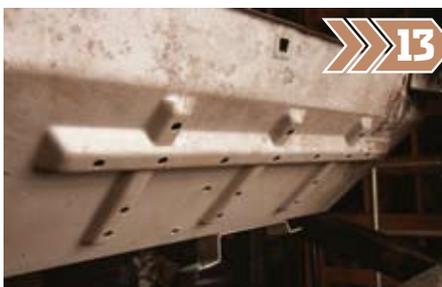
13

Defender footwells are a different shape to Series and at present replacements are not available. 'As a result, we repair them using parts of other bulkheads which have rotted in different places', explains Lyn.

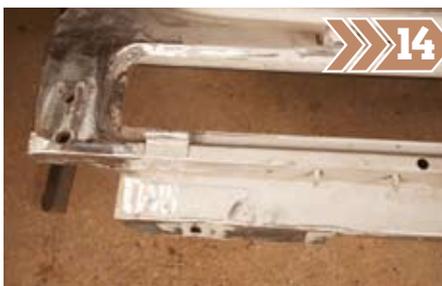
14

Similarly repaired is this Lightweight top bulkhead, which was rotted right through in the top corners. After blending the new metal in, it's time for galvanizing.

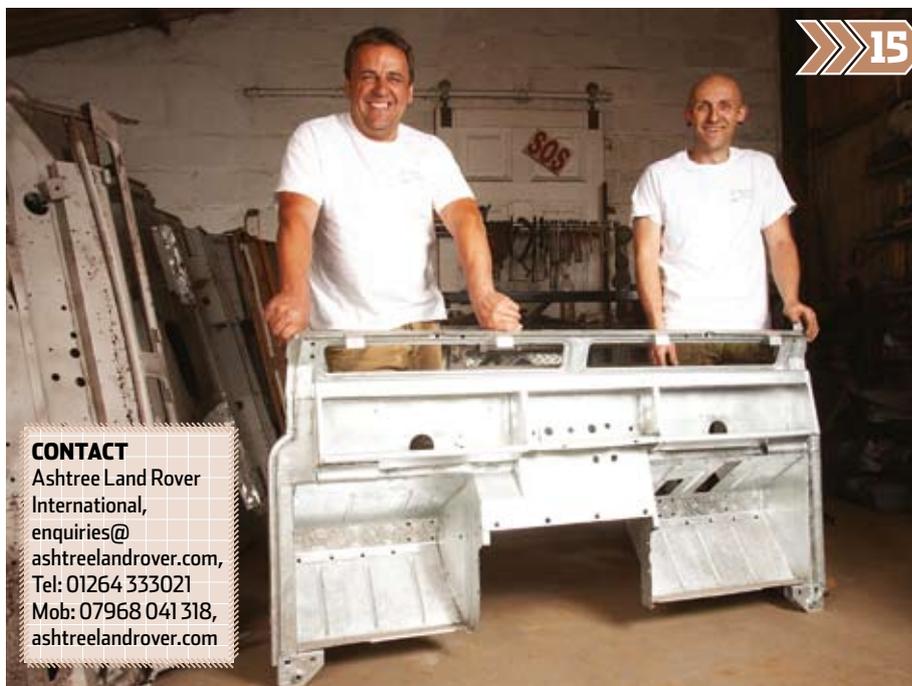
15

Lyn and Kev show off a finished bulkhead for a six-cylinder Series IIA. 'We have very few problems with the galvanizing as the guys at the plant have really got the hang of them now. We drill a few extra holes in the closed sections and a couple in the top to allow the gases to escape and the galv to flow into all the nooks and crannies.' The finished bulkhead is cleaned up and all threads re-tapped ready for assembly. There's 25 microns of galv on each of these bulkheads, losing on average .5 microns a year. In theory, this means it will last for 175 years!
